Manhole Inspection Summary

Manhole # S45MM_032MH

Insp Date: **3/26/08 12:18 PM**

Location Address: **Sinclair**

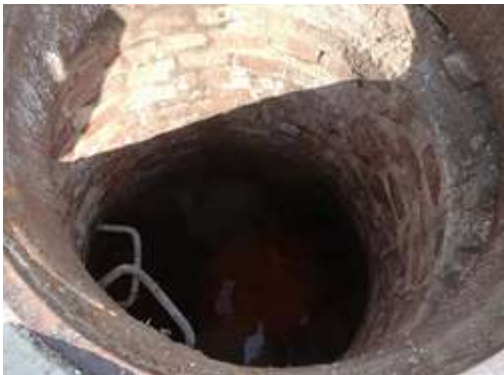
Defect 2

☒ **Leaks**

Frame Leaks

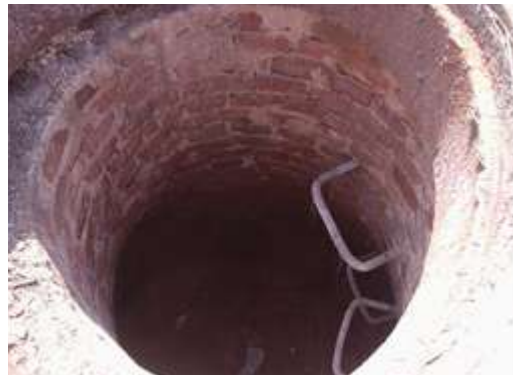
Defect 1

Infiltration: ☐ None ☐ Joint ☐ Cracks ☒ **Mortar** ☐ Roots ☒ **Wall**

Adjustment Joint

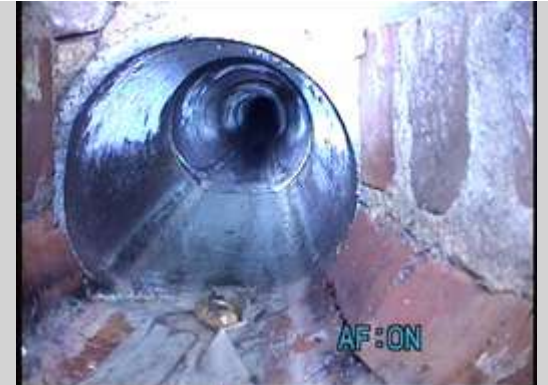
12 O'Clock Outflow

8 in. Circular Gravity Sewer
Pipe Out @ 12 O'Clock

Pipe Height: **8.4** (in.) Rod and Bar (Angled)
Pipe Material: **Clay** ☐ Pipe Lined
Invert Depth: **8.40** (ft.) Flow Characteristics: **Fast**
Deposits: ☒ None ☐ Mud ☐ Sludge ☐ Debris ☐ Grease
Silt Depth: (in.) Deposits Extent:
Infiltration: **None** Pipe Seal Cond: **Sound**

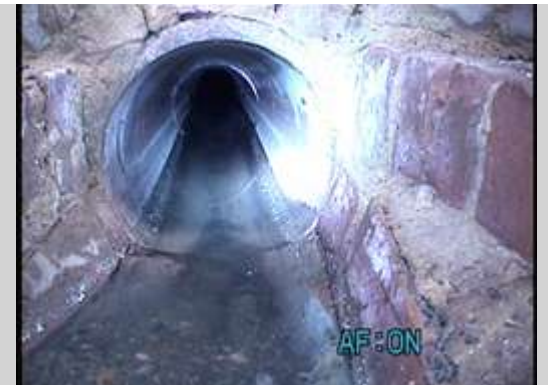
3 O'Clock Inflow

8 in. Circular Gravity Sewer
Pipe In @ 3 O'Clock

Pipe Height: **8.4** (in.) Rod and Bar (Angled)
Pipe Material: **Clay** ☐ Pipe Lined
Invert Depth: **8.10** (ft.) Flow Characteristics: **Slow**
Deposits: ☒ None ☐ Mud ☐ Sludge ☐ Debris ☐ Grease
Silt Depth: (in.) Deposits Extent:
Infiltration: **None** Pipe Seal Cond: **Sound**
